# Fiber Orientation in Fiber-Reinforced Plastics and How it Affects Automotive Applications

E. M. Rowbotham  
Ford Motor Co., Ltd.

Automotive Engineering Congress  
Detroit, Mich.  
February 25 - March 1, 1974

740264

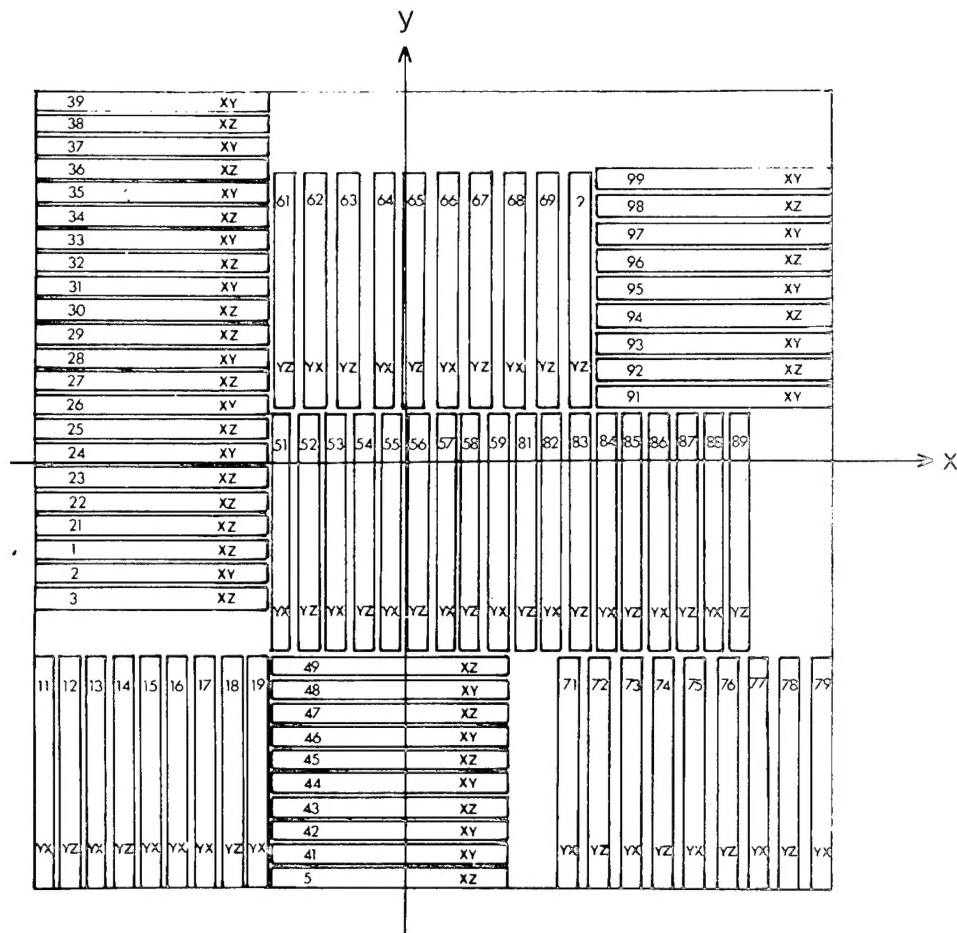
While we suspected that fiber orientation was contributing to the scatter, we did not appreciate the extent. A detailed investigation was instigated on a simple molded plaque ( $305 \times 305 \times 6\text{ mm}$ ) of DMC (15% glass content, 6 m fiber length) to identify the principal factors involved. Eighty-seven test pieces were cut from the plaque (Fig. 1) and their cross-breaking strengths measured using a three point loading system.

Fig. 1 - Positions and orientations of specimens

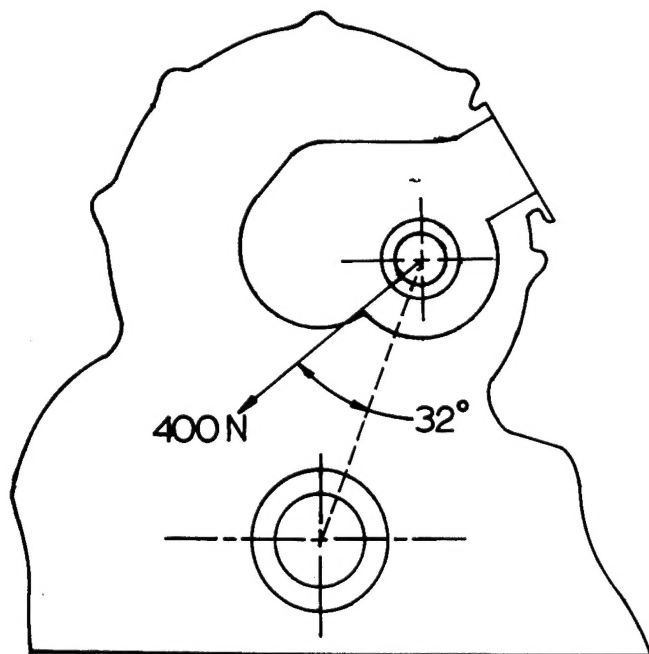
Fig. 7 - Magnitude and direction of load due to fan belt
